# KETRI BUNDER

## WHERE THE SEA IS REDRAWING THE LAND

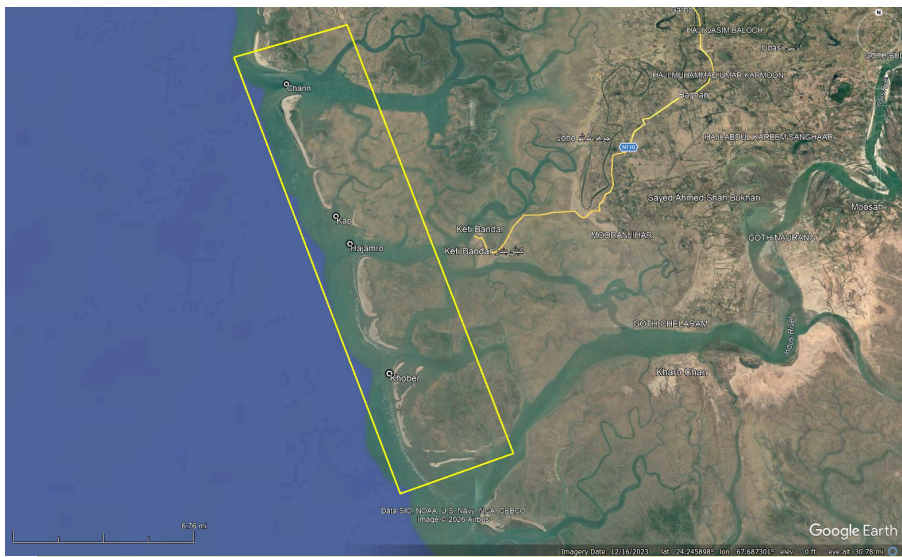
Figure 1: Ketri Bunder as seen on Google Earth Target area highlighted in yellow color

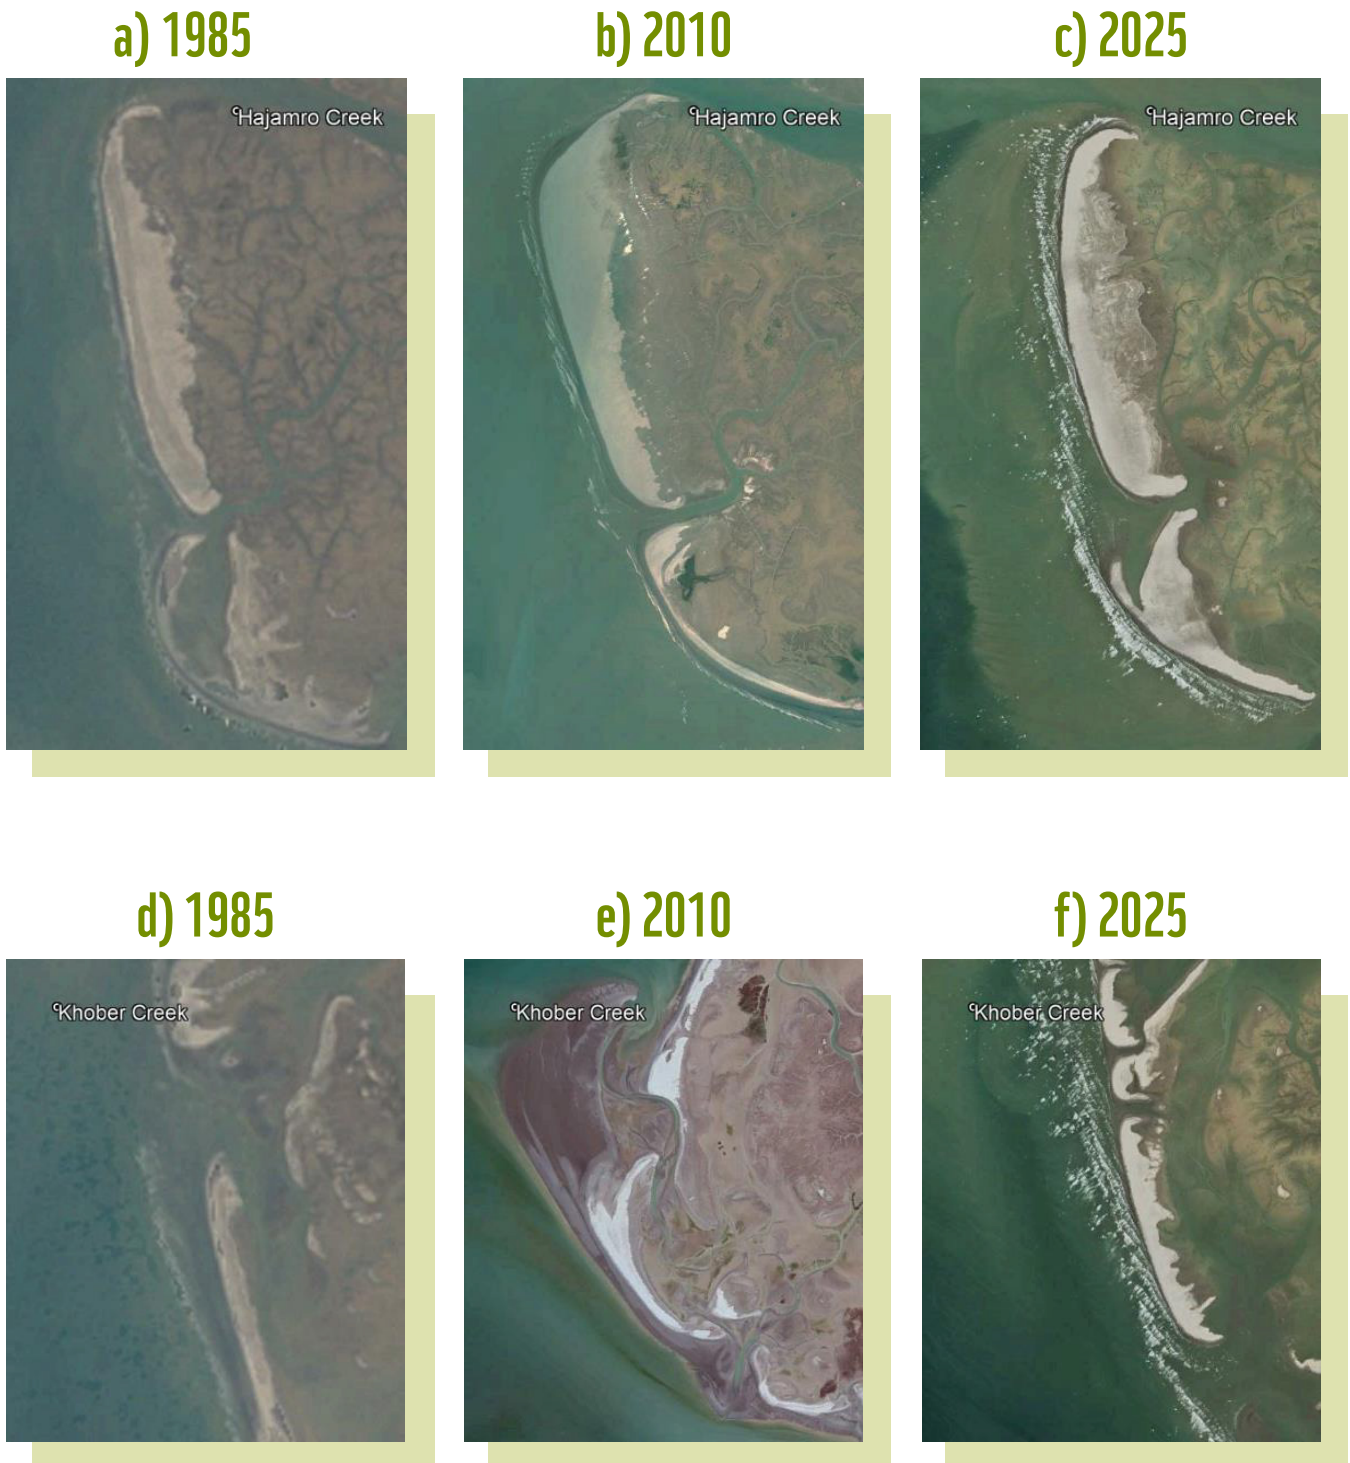
Figure 2: Shoreline change over different years, as witnessed by Google Earth Images Hajamro (a, b, c) and Khober Creek (d, e, f)

The shoreline of Keti Bunder is a living record of change. Some areas show severe erosion, threatening both habitats and livelihoods, while only a few pockets exhibit sediment buildup and limited seaward growth. Stretches near Hajamro and Kap creek, have undergone significant landward migration- evidence of the persistent push of waves and tides. In contrast, smaller areas like Khober creek have seen occasional sediment gain, underscoring the shoreline's complex and uneven dynamics.
